# Manhole Inspection Summary

Manhole # S29CC2015MH

**Location** Address: **5514 BOXHILL LN**

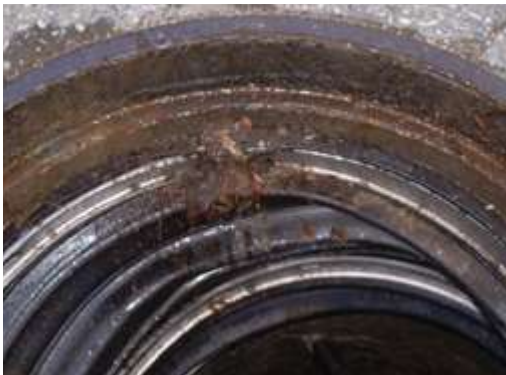
Gasket insert

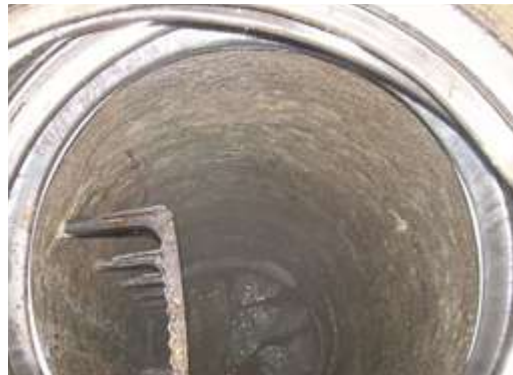
☒ **Leaks**

Defect

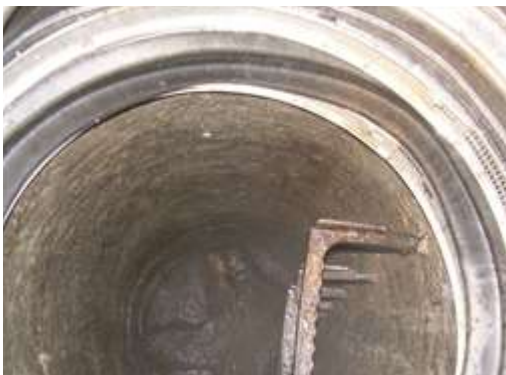
☒ **Joint**

Defect

Adjustment infiltration.

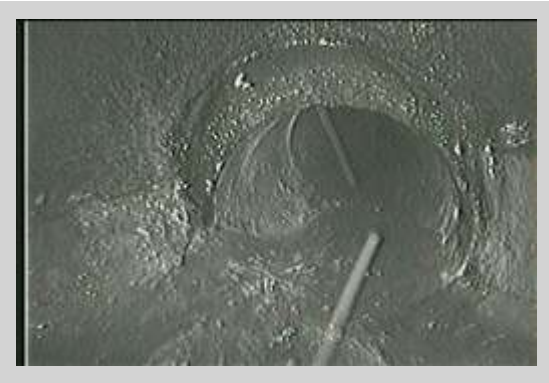
### 15 in. Circular Gravity Sewer Pipe Out @ 12 O'Clock

Infiltration: **Evidence** Pipe Seal Cond: **Unknown**

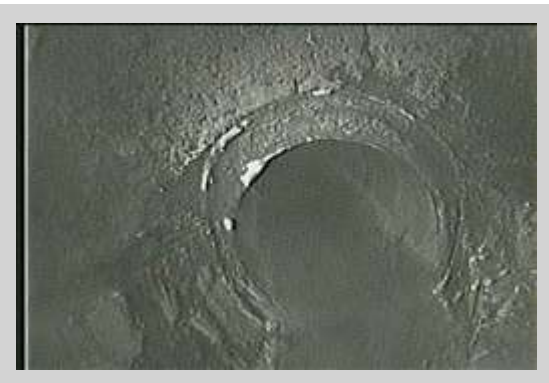
### 15 in. Circular Gravity Sewer Pipe In @ 4 O'Clock

Infiltration: **Evidence** Pipe Seal Cond: **Unknown**

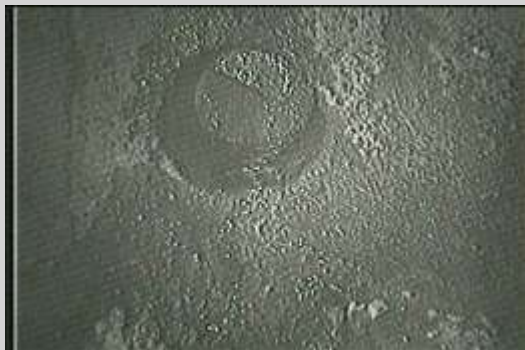
Pipe In @ 9 O'Clock

Connects To: **Stub connection / abandoned**
